**INSPECTOR
BILL**

Property Inspection Report

Inspection Date: 1 Mar 2021

Property Address: Sample Report 0000

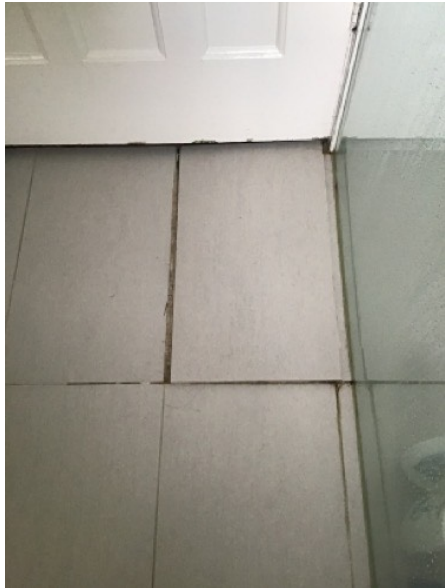
Safety Hazard 1.01

Location: Bathroom

Finding: Tiles - Loose

A loose tile was evident to the tiling in this area at the time of inspection. This area is frequently exposed to water, allowing potential for water penetration into adjoining sections of walls or flooring. If left unmanaged, water penetration to these areas may lead to subsequent water damage, which is likely necessitate repair work to affected building elements. The waterproofing also appears to be sub standard. A tiling contractor should be appointed to ensure that no further water damage occurs.

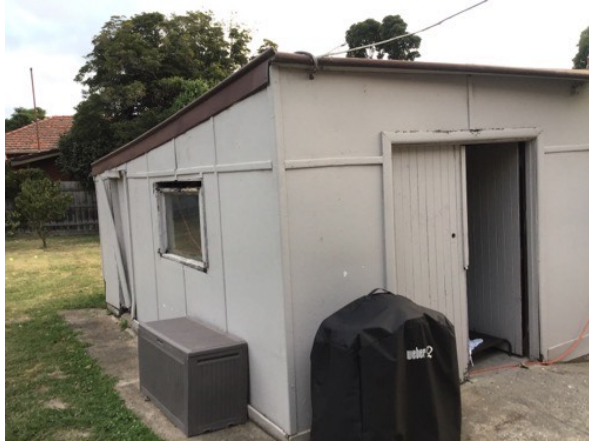
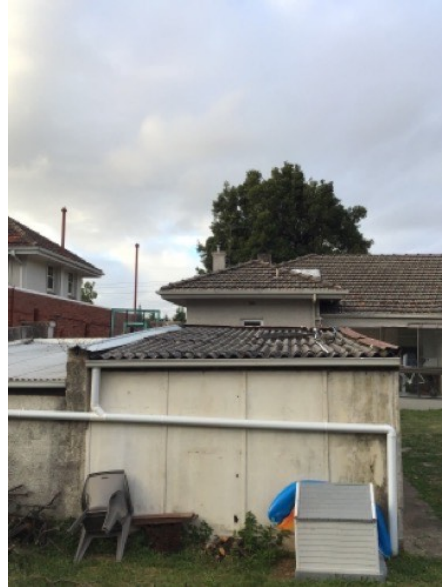
Safety Hazard 1.02

Location: Exterior

Finding: Asbestos

The cladding and roofing material of the shed is likely to be asbestos. A specialist asbestos report is highly recommended.

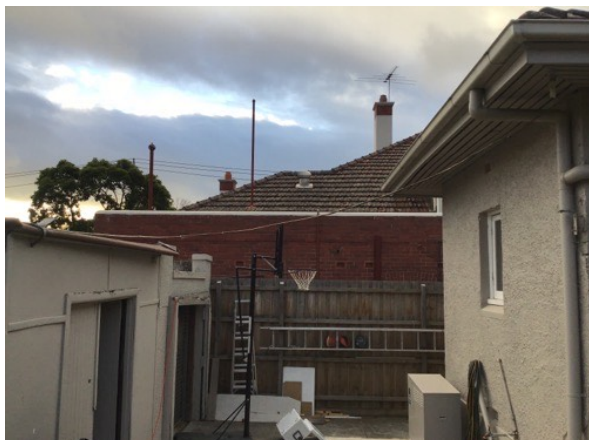
Safety Hazard 1.03

Location: Exterior

Finding: Electrical

Electrical cable has been run externally between the house and the shed without conduit or other concealment. It is highly recommended that a licensed electrician is engaged to assess the electrical work.

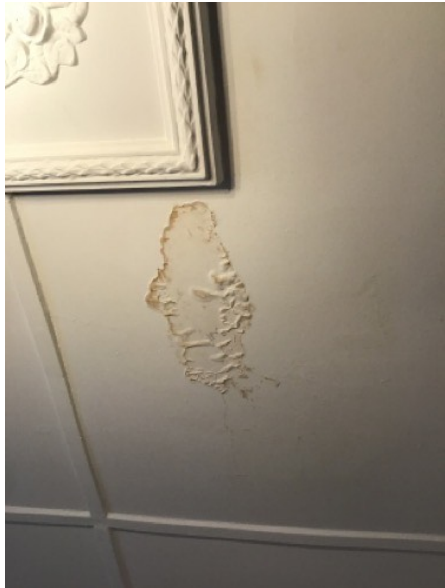
Major Defect 2.04

Location: Lounge room

Finding: Surface - Water stained

Water staining to surface linings in the internal areas was evident at the time of inspection. Water staining indicates that surfaces have been exposed to excessive moisture over time. The minerals and other elements in the water lead to staining. Where water staining is active, a licensed plumber should be consulted to identify the cause of the staining. Where water staining is old and inactive, affected building materials may be repaired or replaced at client discretion.

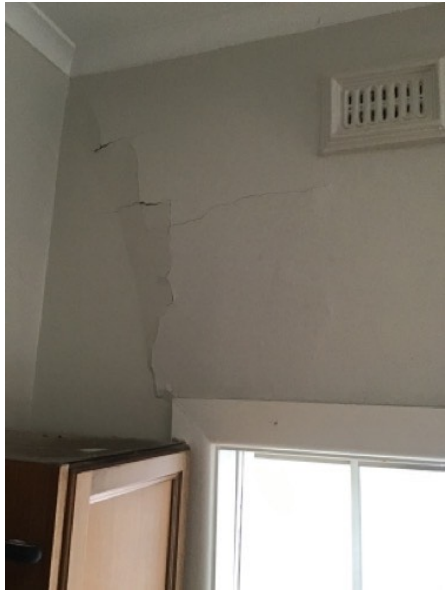
Major Defect 2.05

Location: Kitchen

Finding: Cracking – Plaster lining

Hairline cracks are very minor in nature and are generally an appearance defect. While such cracking may be noticeable, it is quite common and does not indicate any structural damage. Cracking can generally be repaired with minor sanding, filling and repainting. Always contact a building inspector should cracks widen, lengthen, or become more numerous.

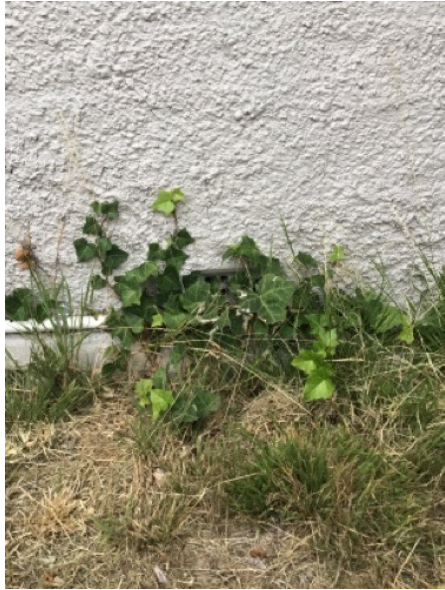
Major Defect 2.06

Location: Exterior

Finding: Lack of ventilation

It was noted at the time of inspection that the subfloor area lacks adequate ventilation. Ventilation can be restricted by a variety of obstructions in the subfloor space, a lack of vents or low clearance. The client may also consider mechanical ventilation to improve subfloor airflow. In this case ivy needs to be removed from brick vent.

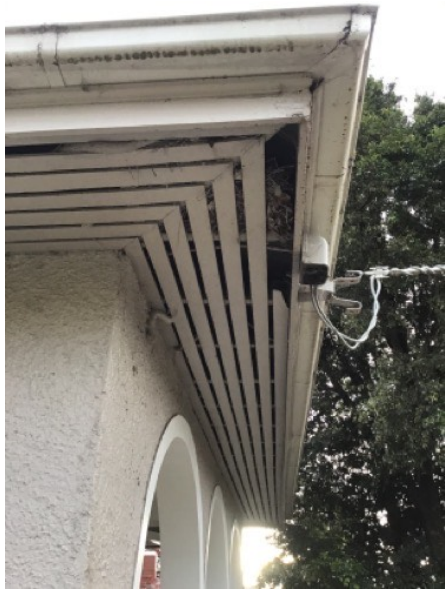
Major Defect 2.07

Location: Exterior

Finding: Eaves - Damaged

The eaves around the exterior property were found to be in poor condition. The damage sustained is a result of a number of poor roof drainage and leaking roof plumbing. The damage to the eave sheeting in this area detracts from the appearance of the structure, as well as potentially compromising the structural integrity of the roofing area. Where eaves show moderate to severe damage, appointment of a licensed plumber is advised to identify the source of the water leak. Eaves had plant growth and signs of birds nesting which could compromise the structure of the roof.

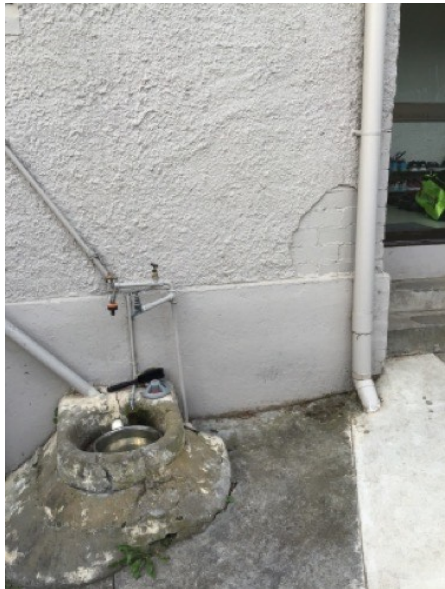
Major Defect 2.08

Location: Exterior

Finding: Site drainage - Inadequate

The downpipe on the external wall of the laundry was found to be inadequate at the time of inspection, creating for subsequent water damage to building elements. It is important that water does not lie against the base of walls; surrounding paths and ground levels should be sloped to drain water away from walls. Downpipes should not disgorge stormwater onto lower walls or plinths. Stormwater should be carried away by drains. A qualified plumber should be appointed to further inspect the property and perform any remedial works as necessary.

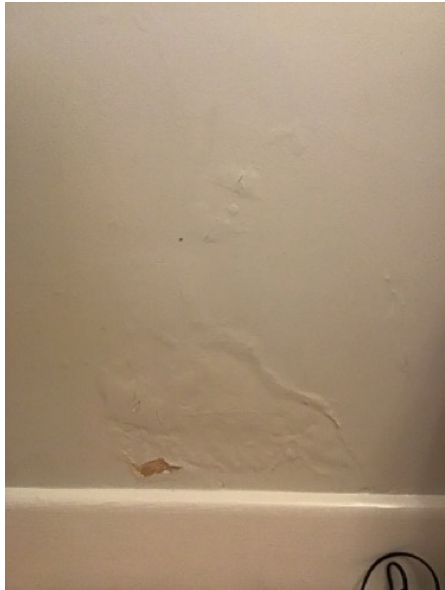
Minor Defect 3.09

Location: Bedroom 1

Finding: Paint finish - Substandard

The paint finish in this area was found to have been completed to a substandard level. Substandard paint finishes should be sanded back, filled, levelled and repainted, as applicable. A painting contractor should be appointed to perform necessary works to aid the appearance of the affected area and to ensure that the area is protected against further deterioration.

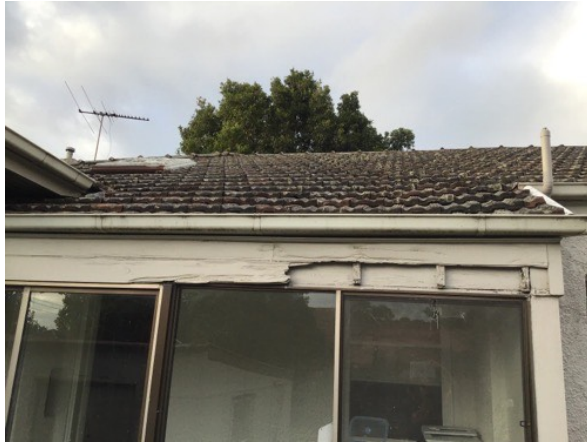
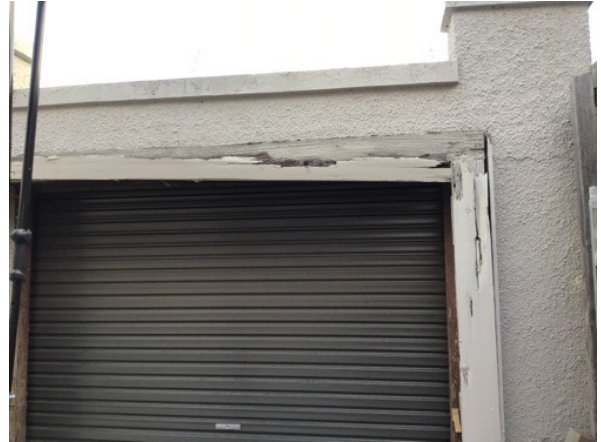
Minor Defect 3.10

Location: Exterior

Finding: Fascia - Rotting

The external fascia show signs of fungal decay in several areas. This wood rot is suspected to have developed over a prolonged period of time due to expected age and condition. To maintain the condition of the external wall cladding, severely affected fascia should be replaced.
